# Safe Hydraulic News

## Hose Cracks

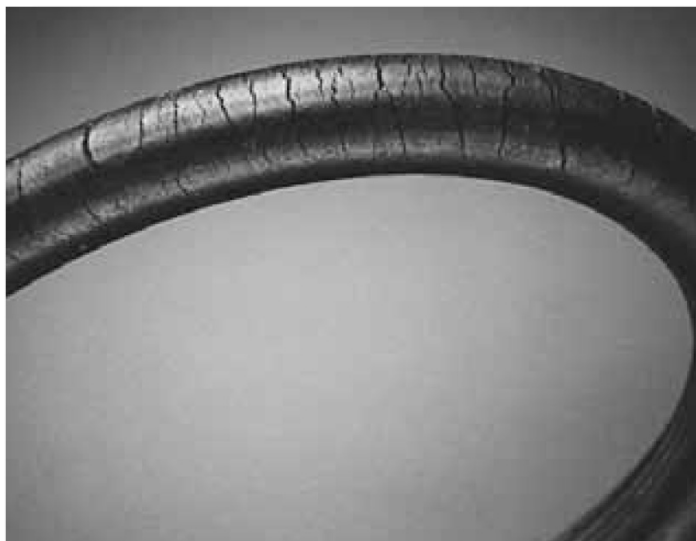
### Problem:

If a hose cover or tube has cracks and appears hardened, this is typically caused by exposure to excessive heat and/or ozone.

Excessive heat can be created by:

- Routing near a heat source such as an exhaust manifold.
- Using an undersized hose or reservoir.

An increase of 10°C above the maximum temperature may decrease hose life by half. Cracks can also be caused by flexing, especially at excessively low temperatures. Never exceed the temperature rating of the hose.

### Solution:

Select a hose that meets the temperature and flow requirements of the application. Also, identify the heat source and consider re-routing it away from the source to minimize the heat's effects.

Examine reservoir size [if necessary].
